Manhole Inspection Summary

Manhole # S39MM_047MH

Insp Date: **2/5/07 11:36 AM**

Location Address: **909 22ND ST**

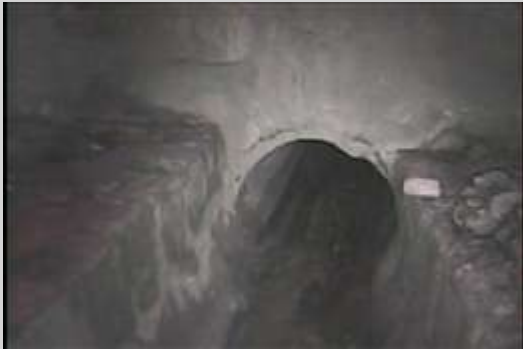
8 in. Circular Gravity Sewer Pipe Out @ 12 O'Clock

Pipe Material: **Clay** ☐ Pipe Lined

Invert Depth: **12.45** (ft.) Flow Characteristics: **None**

Deposits: ☒ None ☐ Mud ☐ Sludge ☐ Debris ☐ Grease

Infiltration: **None** Pipe Seal Cond: **Sound**

Drop: **None**

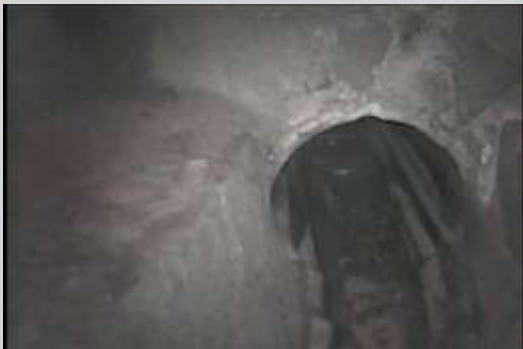
8 in. Circular Gravity Sewer Pipe In @ 3 O'Clock

Pipe Material: **Clay** ☐ Pipe Lined

Infiltration: **None** Pipe Seal Cond: **Sound**
